# PROPERTY INSPECTION REPORT

1213 Sample Drive, Hometown, Texas

February 1, 2009

Inspection Report provided by Gibbs Residential Inspections

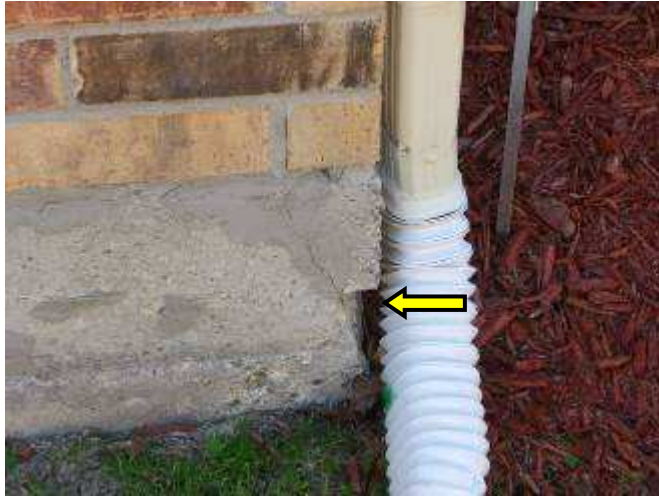
**Corner pop**

Comments: There are compression cracks (corner pops) on one or more corners. Corner pops are cosmetic in nature and do not present a structural concern. They may be repaired with a concrete patch.

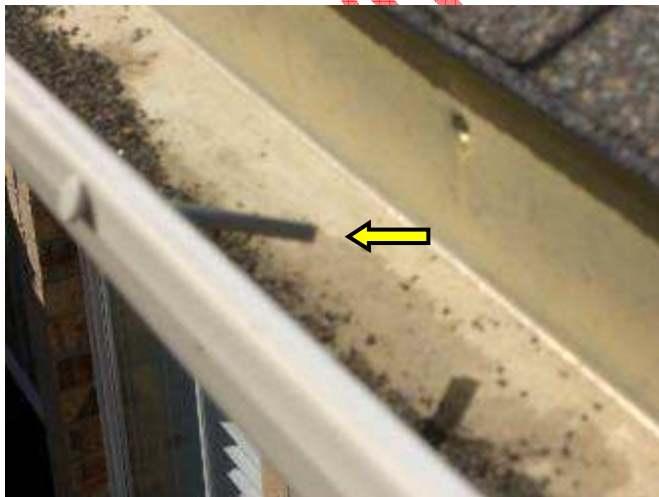
**Broken fastener**

At the rear of the home one gutter is loose. There are missing and damaged fasteners. There is a hole in the gutter.

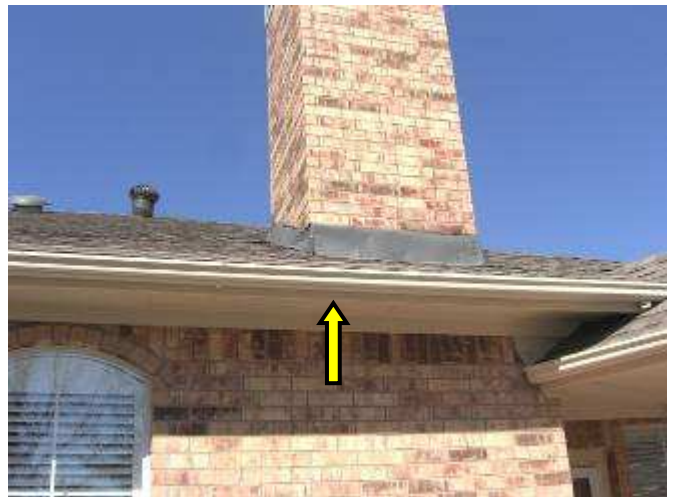
**Loose gutter**

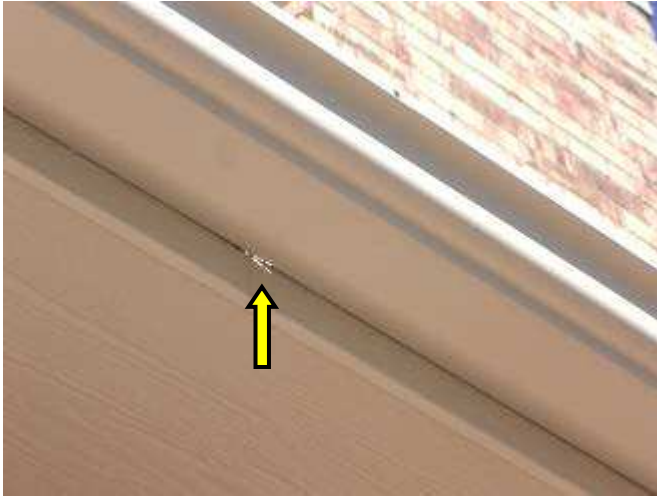
**Hole in gutter**

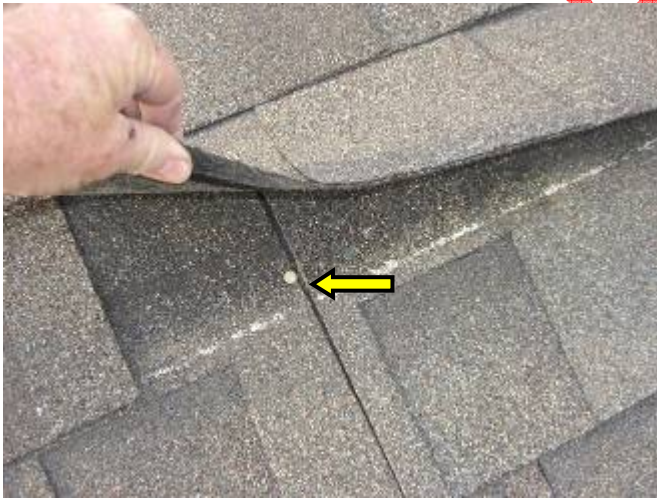
**Nail too close to edge of shingle**  
**Nail above nail line**

Shingles are incorrectly fastened.

- Nails are under driven. The head of the nail should be driven to the surface of the shingle.
- Nails are driven too close to the edge of the shingle. Nails should be no closer than 1" from the edge.
- Nails are improperly placed. Nails should be centered between the key and the tar strip.
- Nails were not placed on the nailing line.
- Nails are over driven. Nails should not penetrate the shingle.
- Nails are placed too close to or too far from the edge of the shingle. Nails should be placed 1 inch from the shingles edge.

Improper nailing may increase the possibility of wind damage. Improper nailing may affect the manufacturer's warranty.

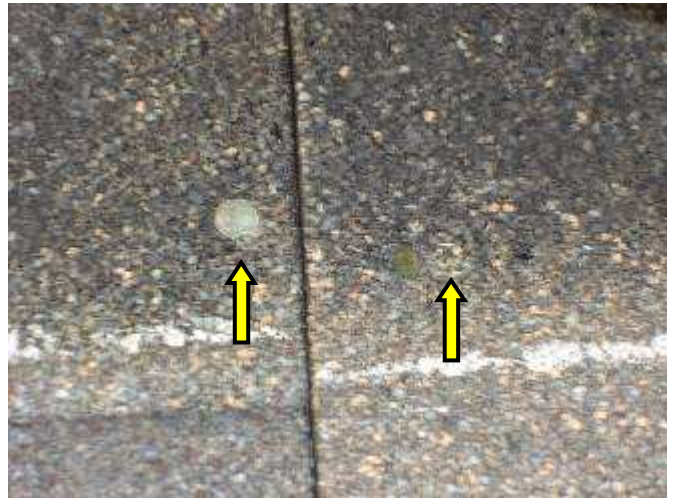
**Nail over driven**  
**Nail too close to edge**

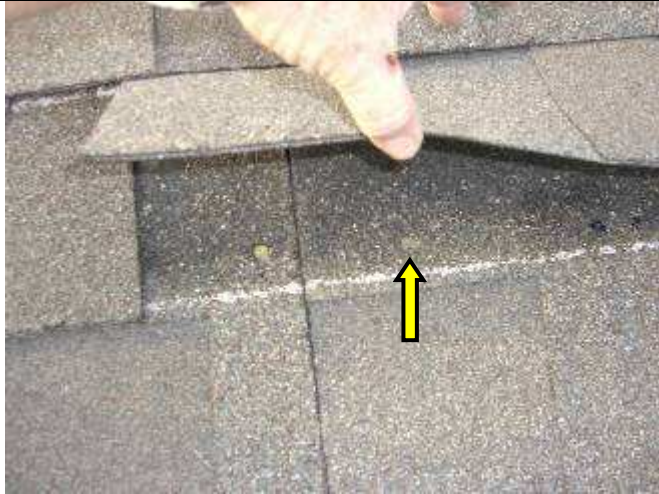
**Nail too far from edge of shingle**

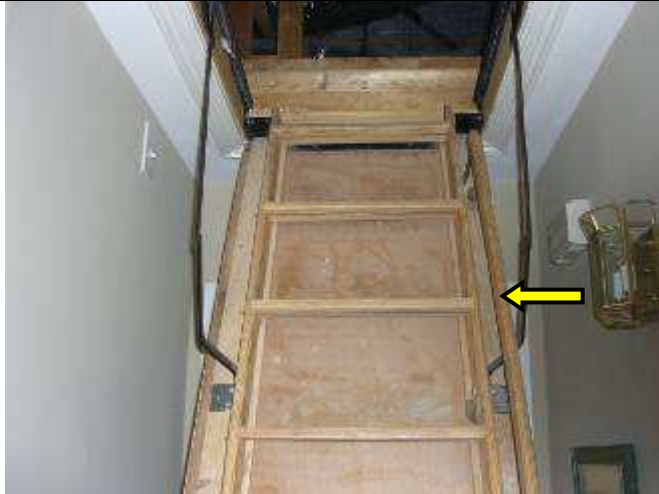
Insulation recommended

**Recommendation:** For the attic inside the home there is no insulation over the attic hatch. Improvement in home efficiency may be improved by the addition of an insulated hatch cover or by adding insulation to the inside of the attic hatch.

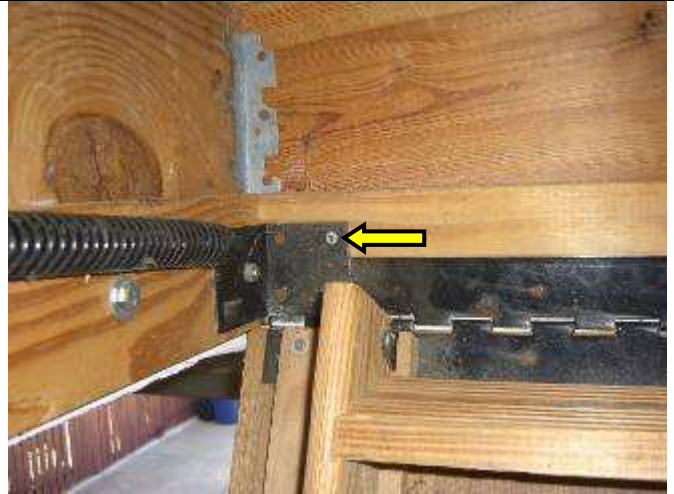
Incorrect fasteners

Neither attic stairways are secured in accordance with the manufactures instructions. Required nailing guidelines were not followed. The access stairs have been secured with improper fasteners. 16 penny common nails or ¼ inch lag bolts should be used.

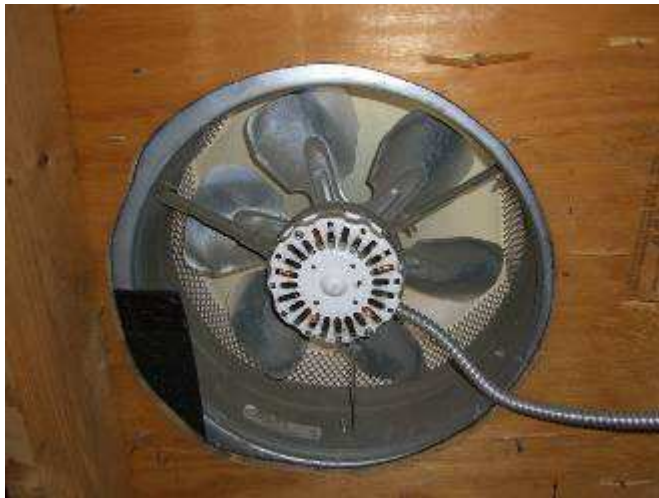
Power vent

The power ventilator appears to be inoperative. The unit should be repaired or replaced.

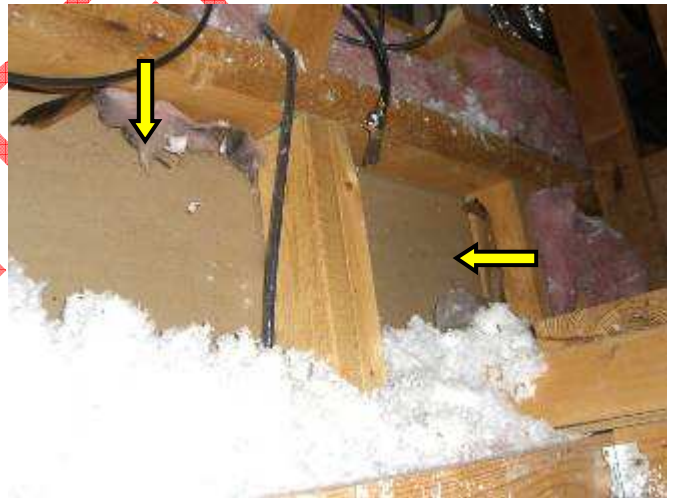
Missing insulation

There are areas where the insulation is missing. These areas will impact the efficiency of the home. Insulation in these areas should be replaced.

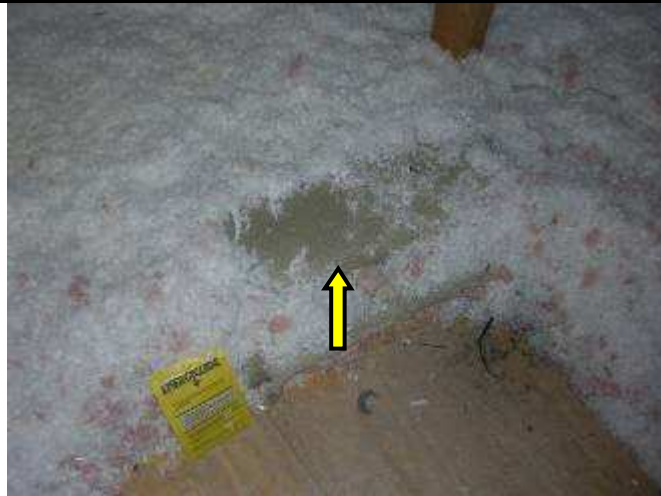
**Carpet in insulation**

There is carpeting buried in the insulation. This impacts the efficiency of the insulation.

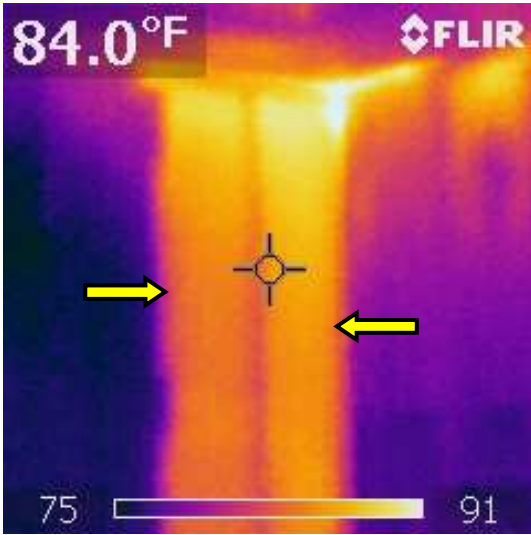
Missing insulation

Deficient insulation was detected in some walls. Areas where insulation was either not installed or was installed improperly were detected in both the master bedroom and the game room.

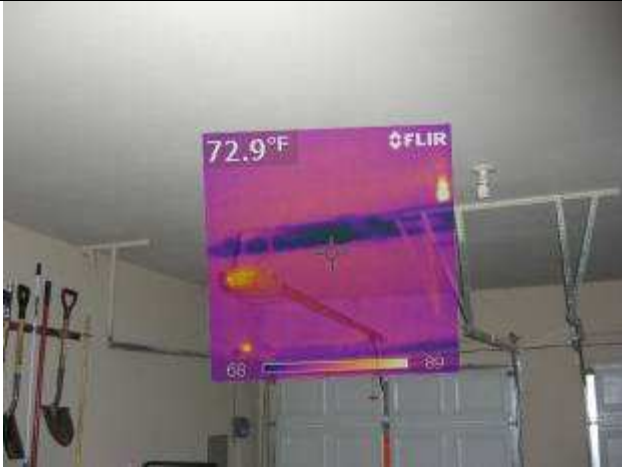
**Moisture in ceiling**

Garage: The ceiling in the garage contains moisture. A bath is located above the garage. There are no visible leaks in the bath.

There appears to be a hidden leak in the upstairs bath. The ceiling in the garage below has high moisture content.

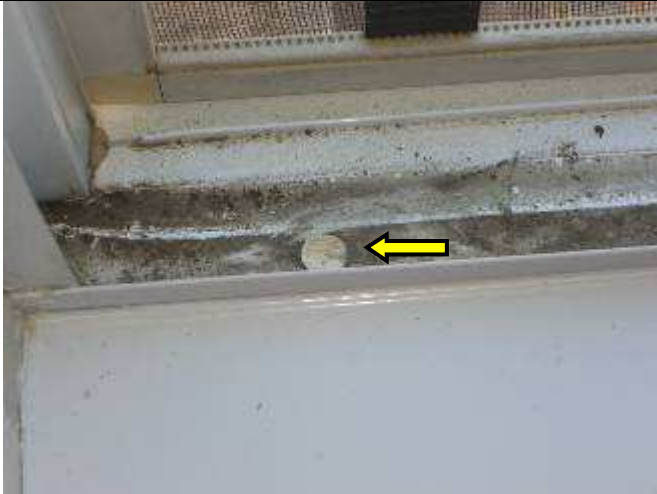
**Caulk Sensors**

- H. Windows – *Comments:*  
Some of the alarm sensors are not caulked. The alarm sensors should be caulked to prevent moisture from penetrating the structure.

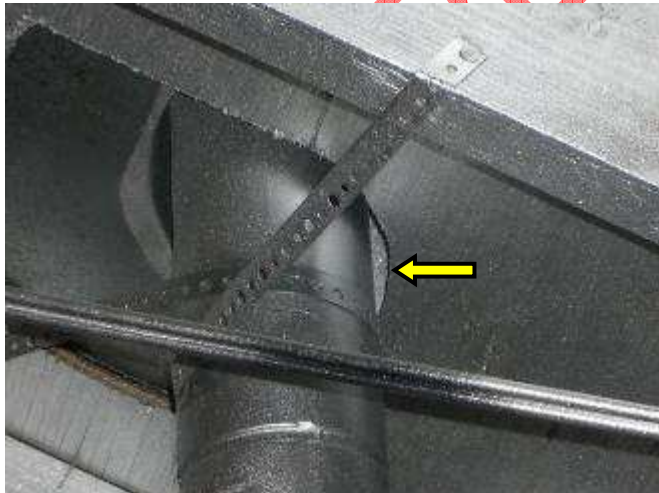
**Insufficient clearance**

The heater vent is improperly installed.  
 • Where it passes through the roof deck, the vent pipe does not have the required 1" clearance from combustible material.

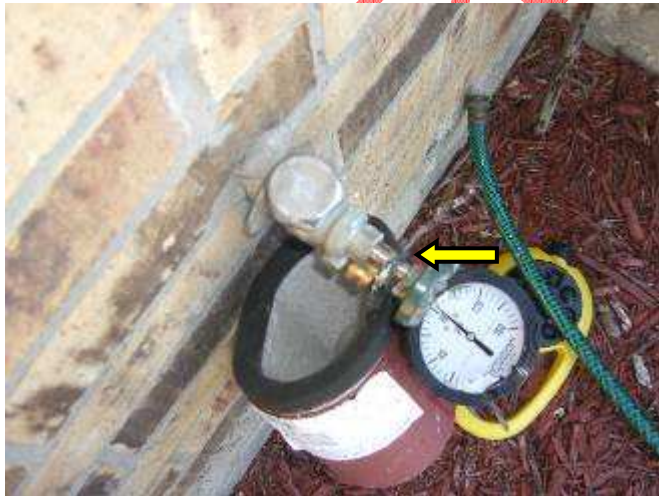
**Stem leak**

Two exterior faucets leak around the valve stems.

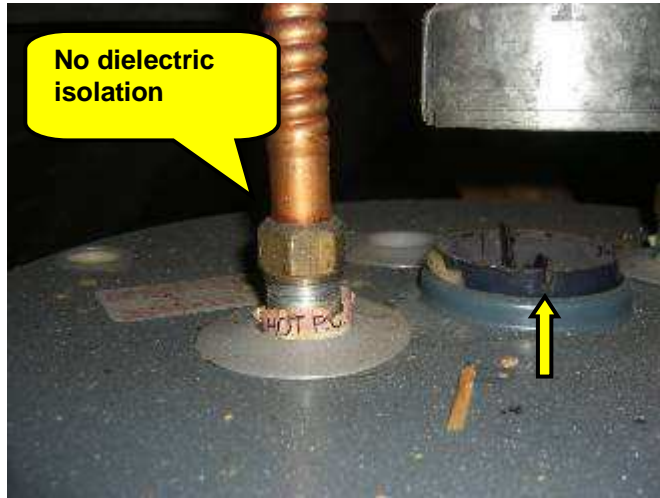
**Draft diverter missing**

The draft diverter is missing. Proper installation of the draft diverter is required to vent harmful gasses and heat to the outside. This needs to be corrected and secured. Recommend a qualified plumber be consulted.

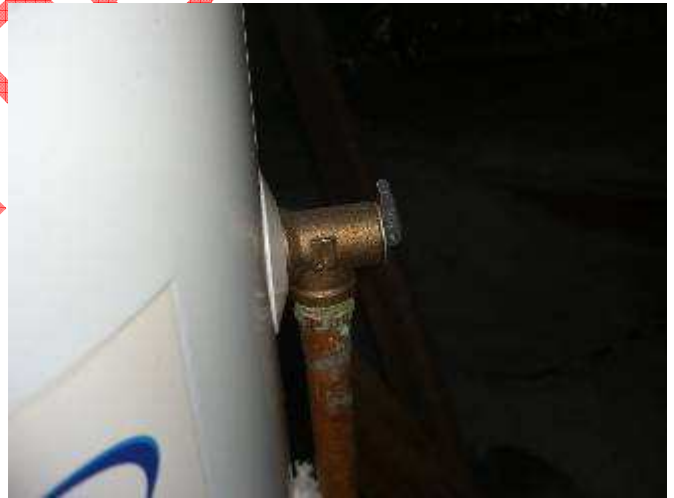
**T&P valve**

When the Temperature & Pressure Relief (T&P) Valve was tested, the test lever appeared to be stuck. I do not force these open because they often do not close properly and they will leak. The manufacturer of the valve recommends they be tested yearly. I recommend a licensed plumber be consulted to repair or replace the T&P valve.

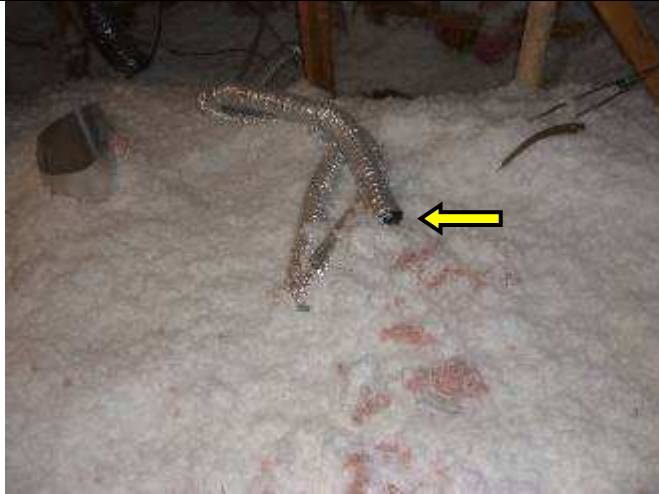
**Vet to attic**

The bathroom vents terminate in the attic. This practice exhausts excess moisture to the attic. Moisture contributes to wood rot and mold.

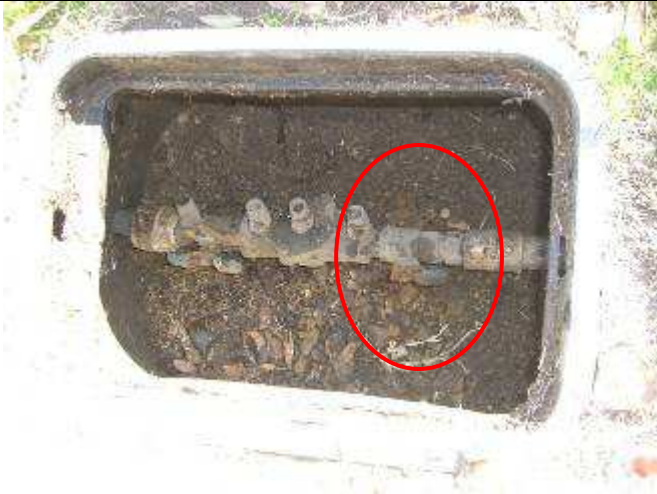
Handle rusted away

At the back flow device one shut-off valve appears to be stuck and the handle is rusted away.

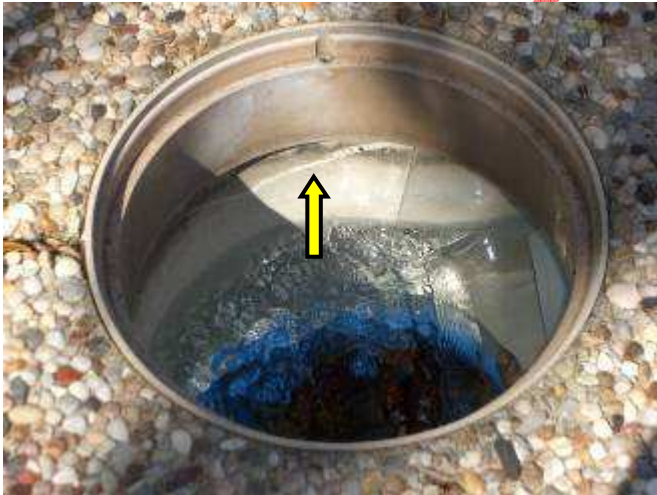
Crack

On one skimmer there is a crack near the top.

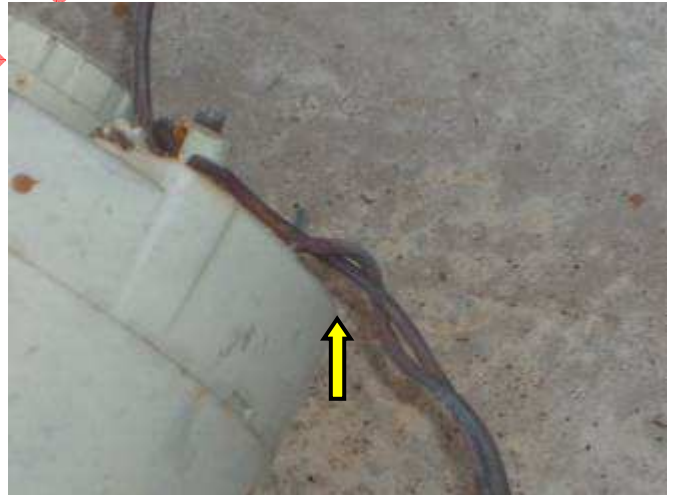
Improper ground connection

The ground connection for the pool sweep motor is incorrectly installed. It is just twisted around another ground cable. It should be secured with a clamp.
